May 11, 1988

Re: Site Inspection, Fivemile Clay Pit, M/045/006

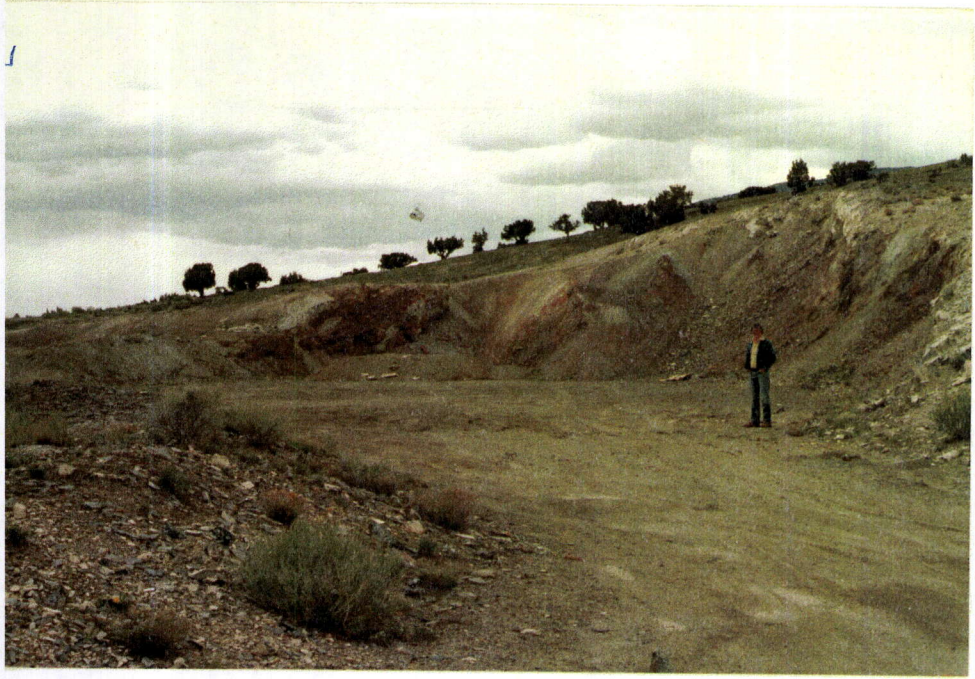
4-28-88
Five Mile m/045/006
Pit 2E Looking Southeastly
7+ 30(11) (active)

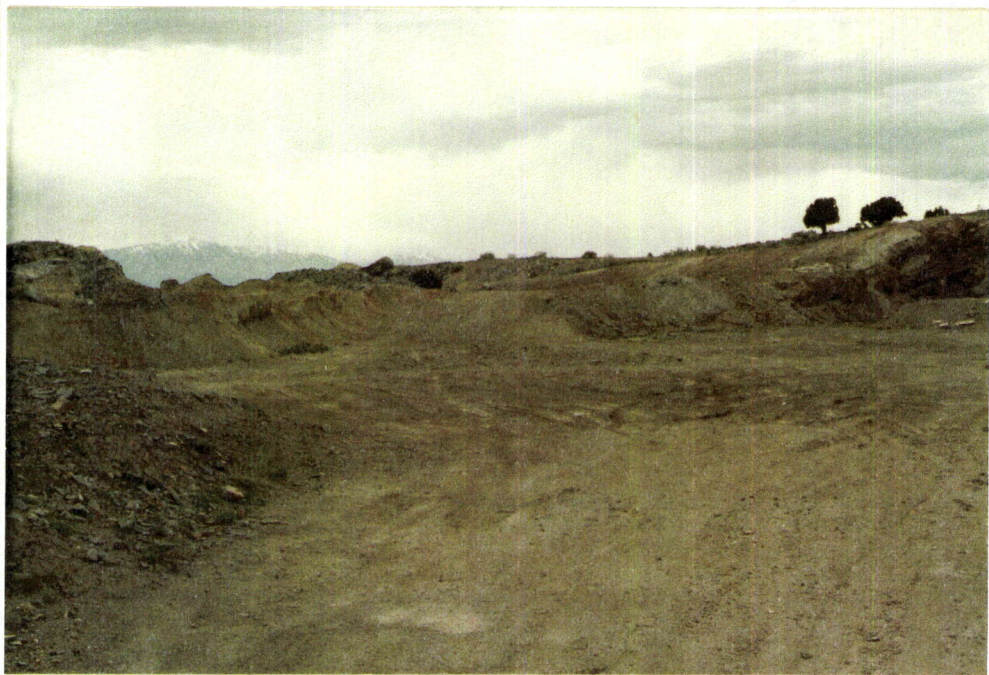
m/045/006 4-28-88
~~Blocked Dr~~ (40)?
Waste Dump ~~2A~~ has been placed
into old pit on the SE end.
3e

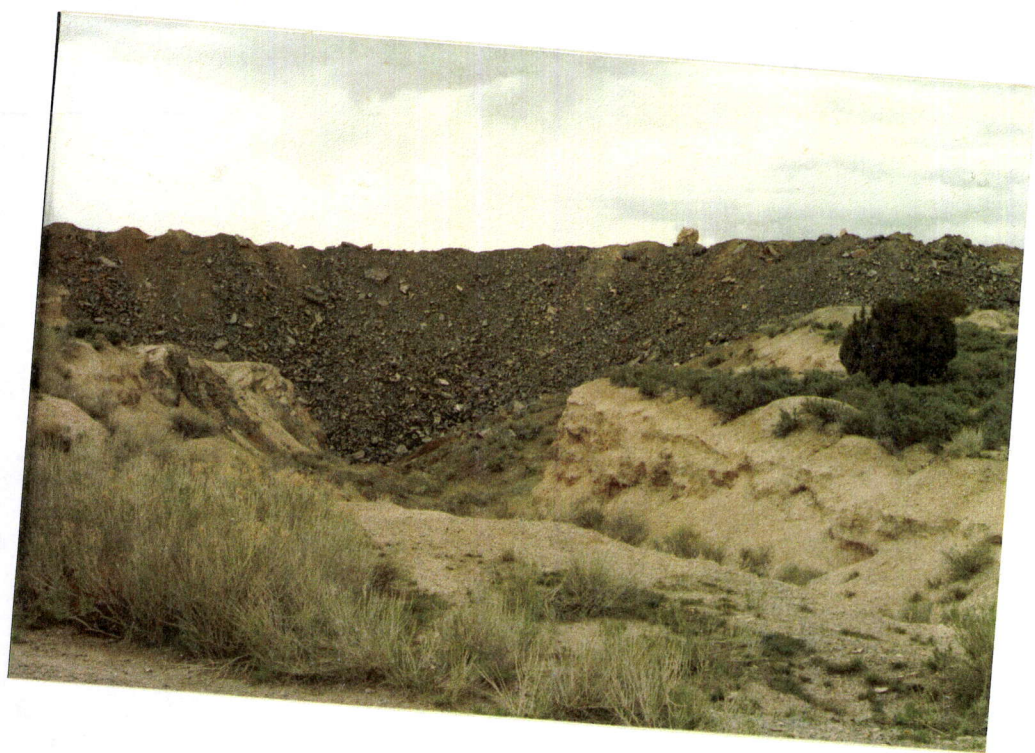
4-28-88
m/045/006
Pit 2A - south side
3A

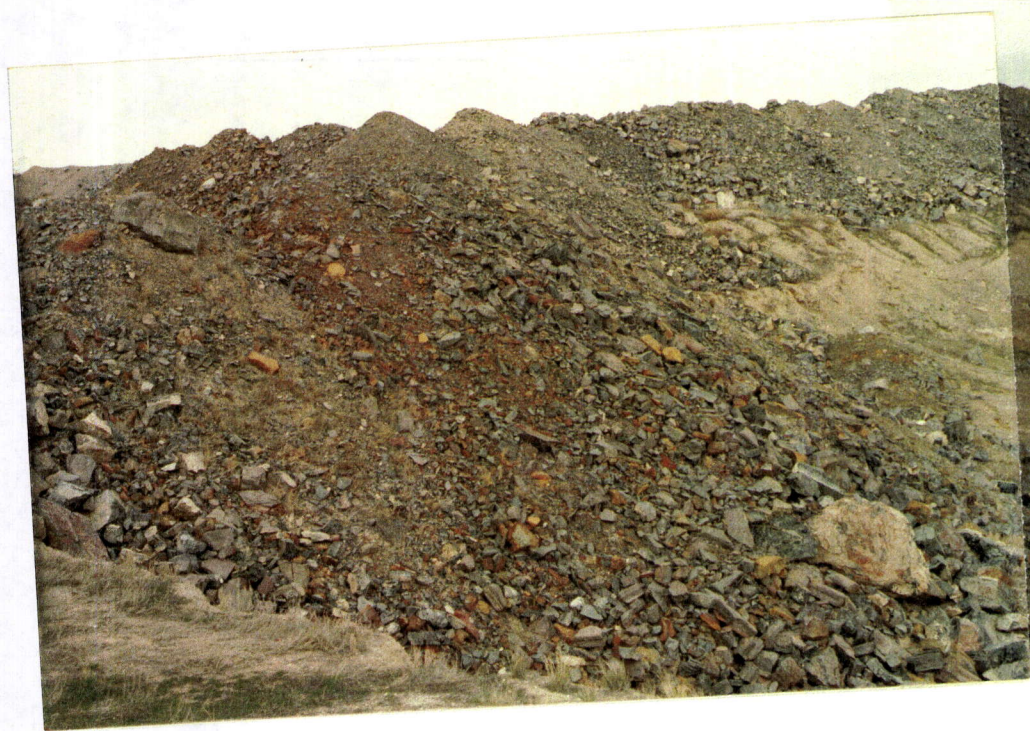
4-28-88
m/045/006
Pit 2A - north side
3A
